ISA Basic Tree Risk Assessment Form

Client San Mateo County Parks Date January 6, 2021 Time 1:30pm
 Address/Tree location 215 Bay Road, Menlo Park, CA Tree no. 13 Sheet 1 of 2
 Tree species Quercus agrifolia - Coast live oak dbh 59" Height 50' Crown spread dia. 66'x66'
 Assessor(s) Daniel Krug Tools used Mallet, Probe, IML Resistance Drill Time frame 1 year

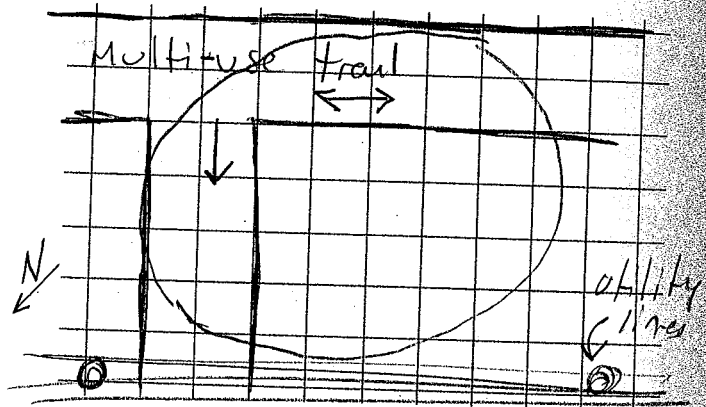
Risk rating may not fully reflect tree condition due to unknown level of trunk & basal decay. Mitigation options

Inspection limitations None Visibility Access Vines Root collar buried Describe Unable to identify extent of internal decay
 ** Resistance drill test returns illustrate significant internal decay, which elevate tree risk to High with no reasonable mitigation options.

1. Restrict access within dripline to picnickers Residual risk Low
2. Restrict use or move Multi-use trail - Not Practical Residual risk N/A
3. Request utility relocate distribution wires - Not Practical Residual risk N/A
4. Residual risk _____
