Flood County Park, Coast Live Oak Inspection

Date: January 6, 2021

ISA Tree Risk Level 3, Advanced Assessment

Flood County Park: 59" Coast Live Oak

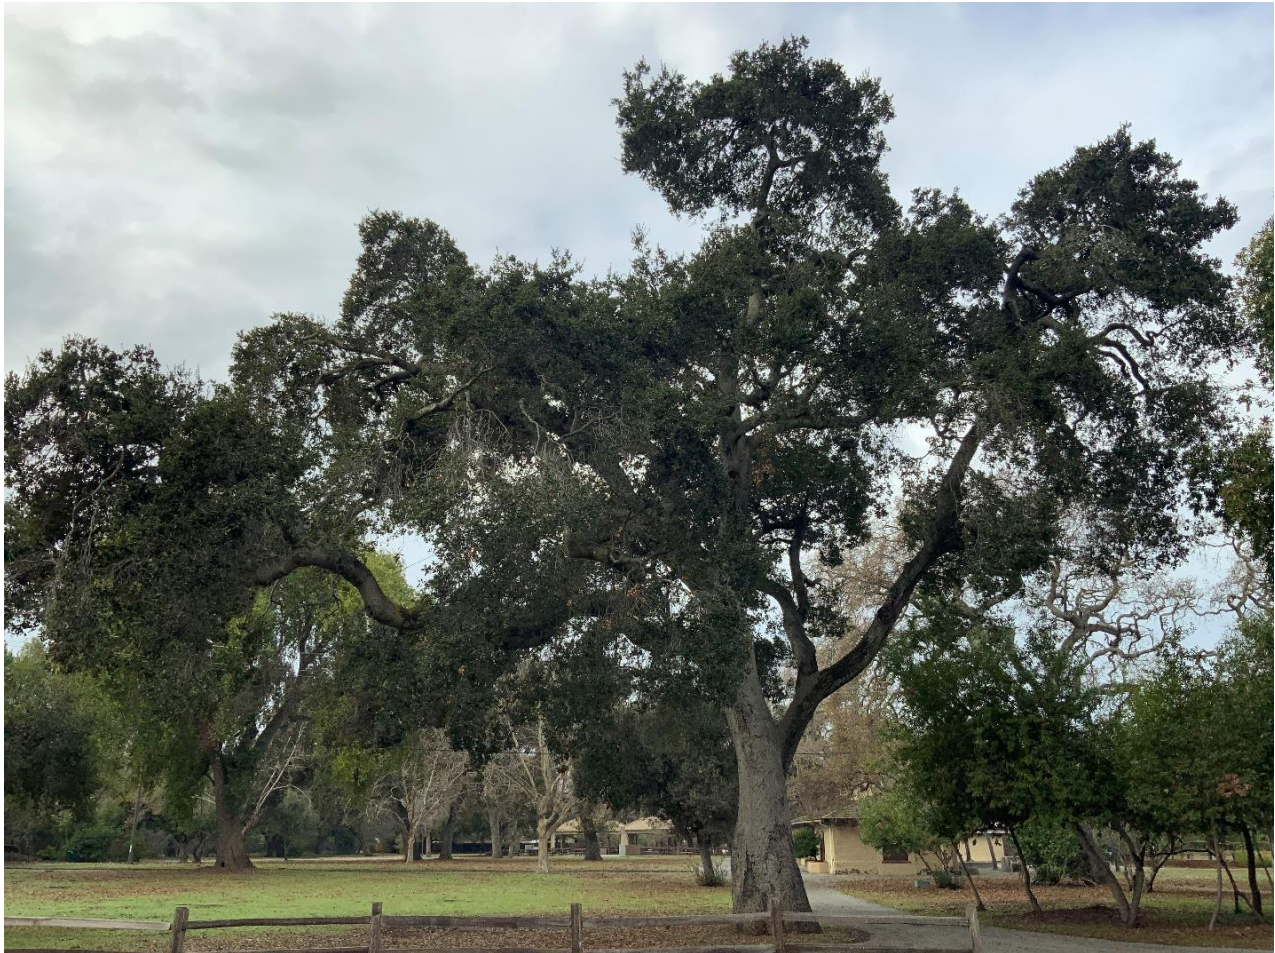
At a distance canopy vigor is fair for the size and species. Retrenchment, a natural state of decline in mature trees is presumed. Signs of this natural canopy decline include flattening of the trees upper canopy and sporadic die-back on branch ends around the canopy. A visual comparison was made to similar oaks in the immediate vicinity to quantify the general state of canopy condition. Interestingly, although adjacent coast live oak exhibit symptoms of foliar diseases such as cryptocline canker or anthracnose no significant infections were observed on the subject tree.

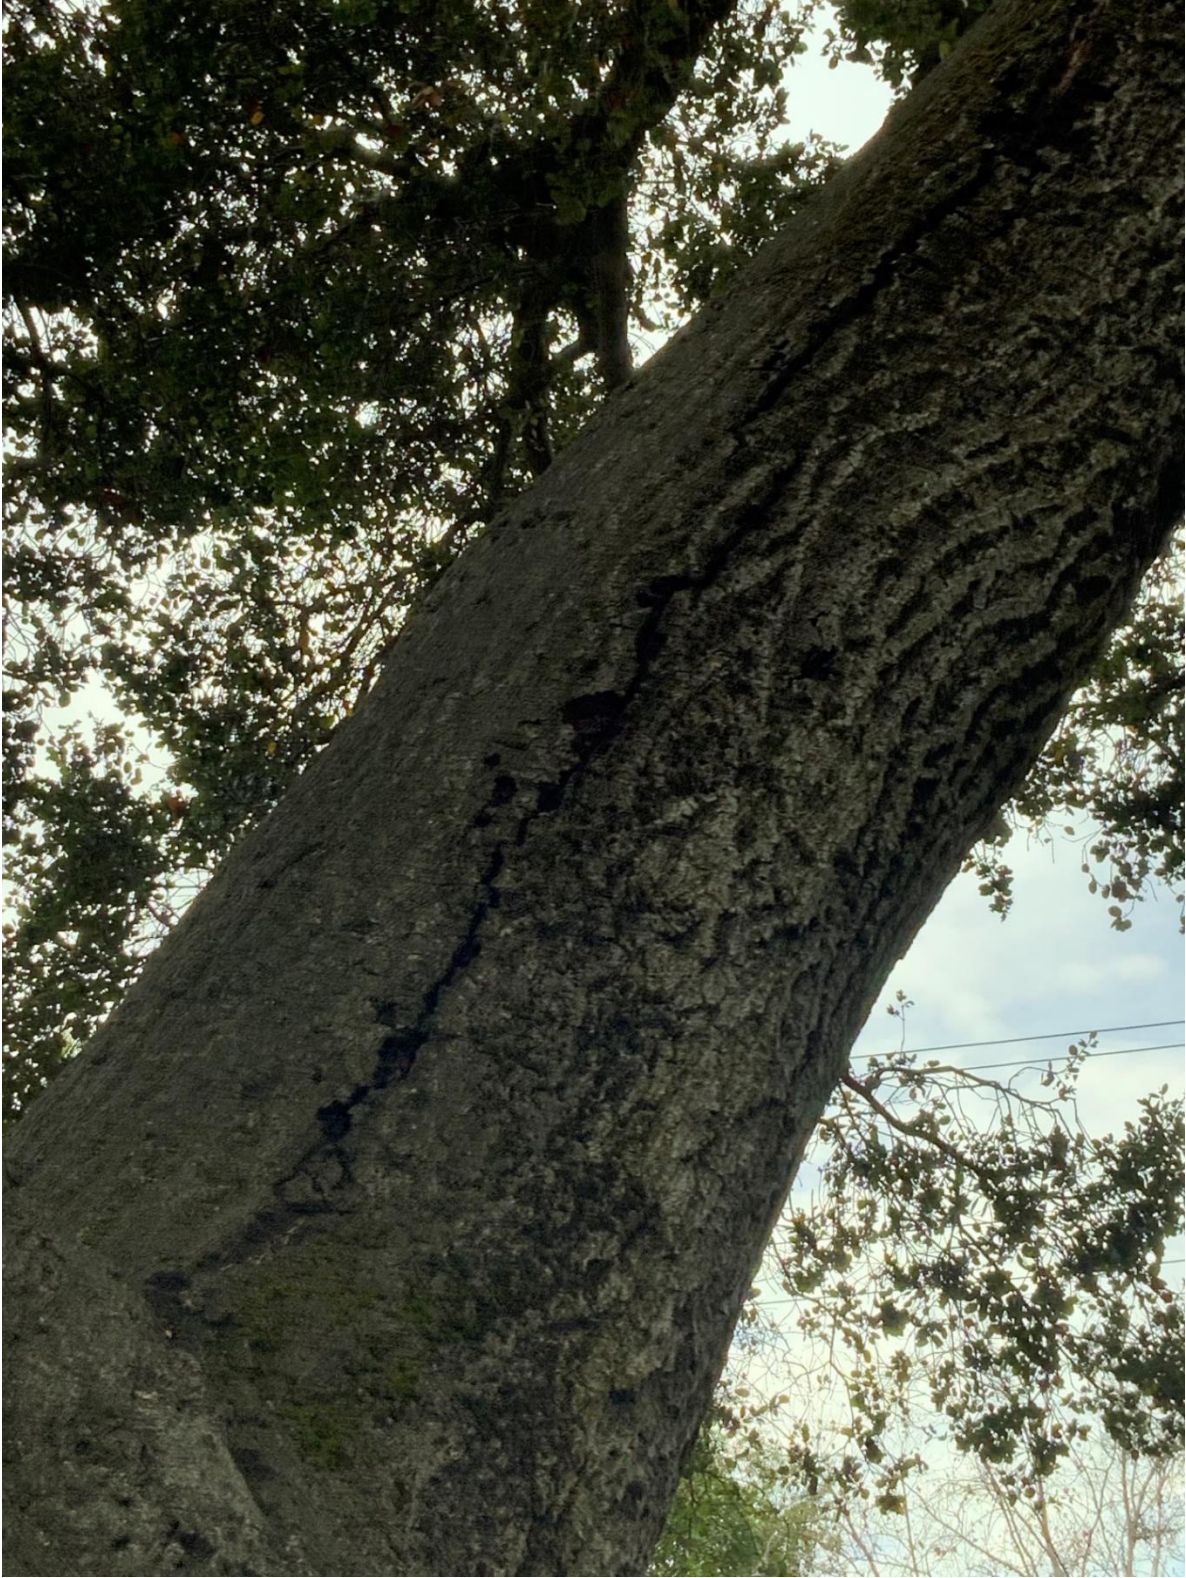
Closer inspection of scaffold and secondary limbs detail signs of excessive branch weight including presence of stress cracks on vertically growing limbs over the multi-use trail. Coast live oak have the capacity to grow rapidly during spring which can cause the outer bark to fissure. However, stress cracks differ from rapid-growth cracks in their visual appearance and orientation of development. Growth cracks may appear anywhere around the circumference of a stem or scaffold limb whereas stress cracks most commonly manifest at the convergence of compression and tension wood. Visual difference between the two types of cracks are apparent in color of the bark within the deepest point of the fissure. Growth cracks will appear brightly colored, either beige or orange, while stress cracks are generally observed as having a dark gray or black appearance.

Stress crack located on a primary stem, 8' above ground level.

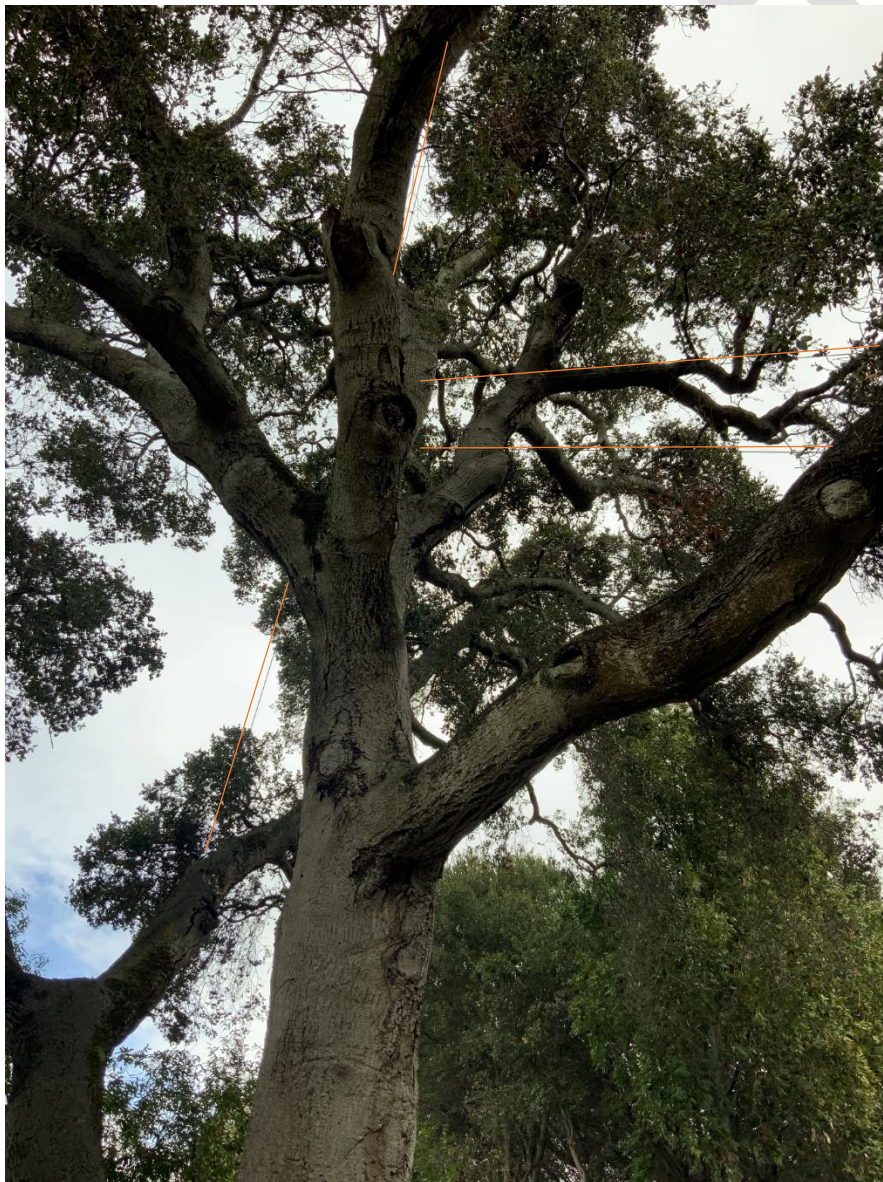
Seven static load cables were observed in the canopy at varying heights. Static load cables are generally installed in trees which are observed as having a defect of concern. Purpose of cable installation is to add support between two co-dominant stems or to support a subordinate stem exhibiting signs of structural weakness, such as included bark, hollow, or poor branch attachment. Provided location of cables and level of callusing around attachment points it is assumed the cables were installed by arborists over the course of several years. Although installation history of cable for this tree is unknown we can assume installation was reactionary to previous limb failure of the subject or neighboring trees. Several other large diameter oak within Flood Park have cables installed in their canopies. Unfortunately, efficacy of cables diminishes as the tree grows resulting in the need to replace and reposition cables. The subject tree's broad retrenching canopy is unlikely to accommodate cable repositioning due to poor attachment angles and an insufficient level of sound wood within the decaying limb structure in the upper canopy to anchor cabling hardware. (lags or eye-bolts)

Four of the 7 cables highlighted in orange. Position of highlight is purposefully offset of position of cable for reference.

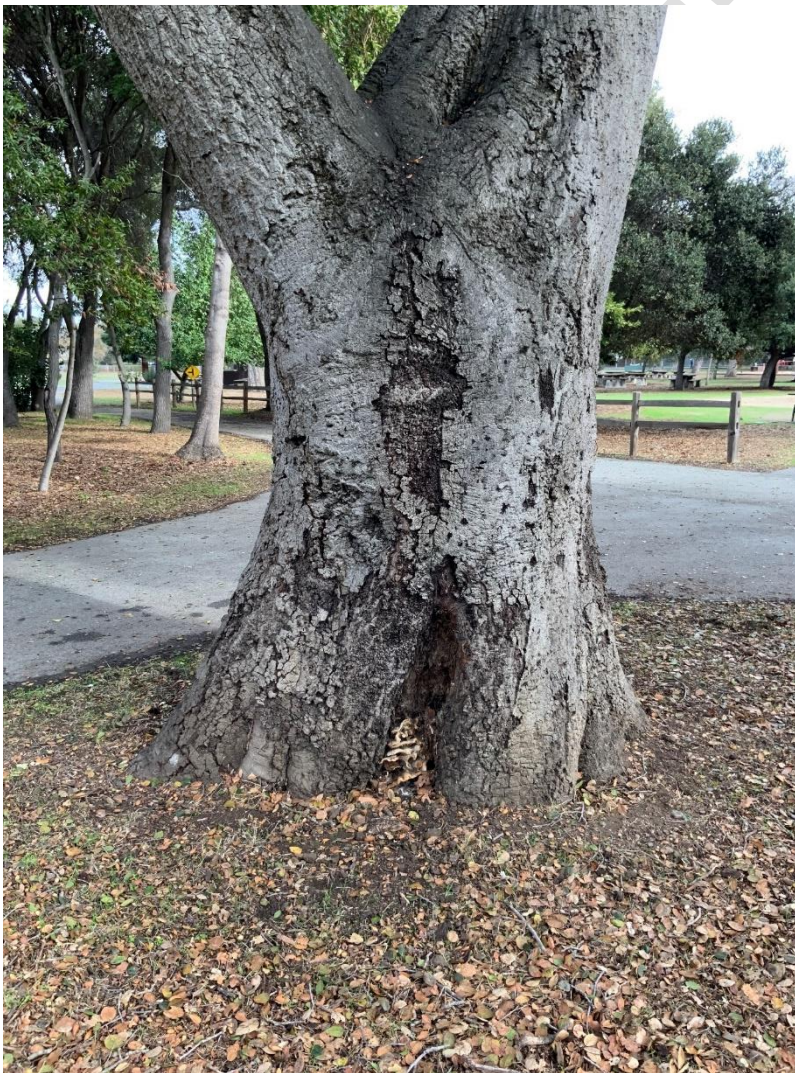
Primary branch attachment and main stem of the tree exhibit signs of internal decay and secondary stressors. A closed callus is visible on the northwest side of the tree where a large limb had been removed many decades ago. Location of this limb is in line with a visible cavity at the base of the tree where fungal fruiting bodies were observed.

Basal cavity and visual evidence of wound closure above main crotch.

Growth of callus on either side of wound indicates internal decay as a long-running issue. Tree also exhibits lack of root flare on west northwest sides of tree which also indicates signs of potential root decay.

Due to severe decay within the basal heartwood of the tree caused by the fungal pathogen, *Laetiporus gilbertsonii* var. *pallidus* removal of the 59" coast live oak is recommended.

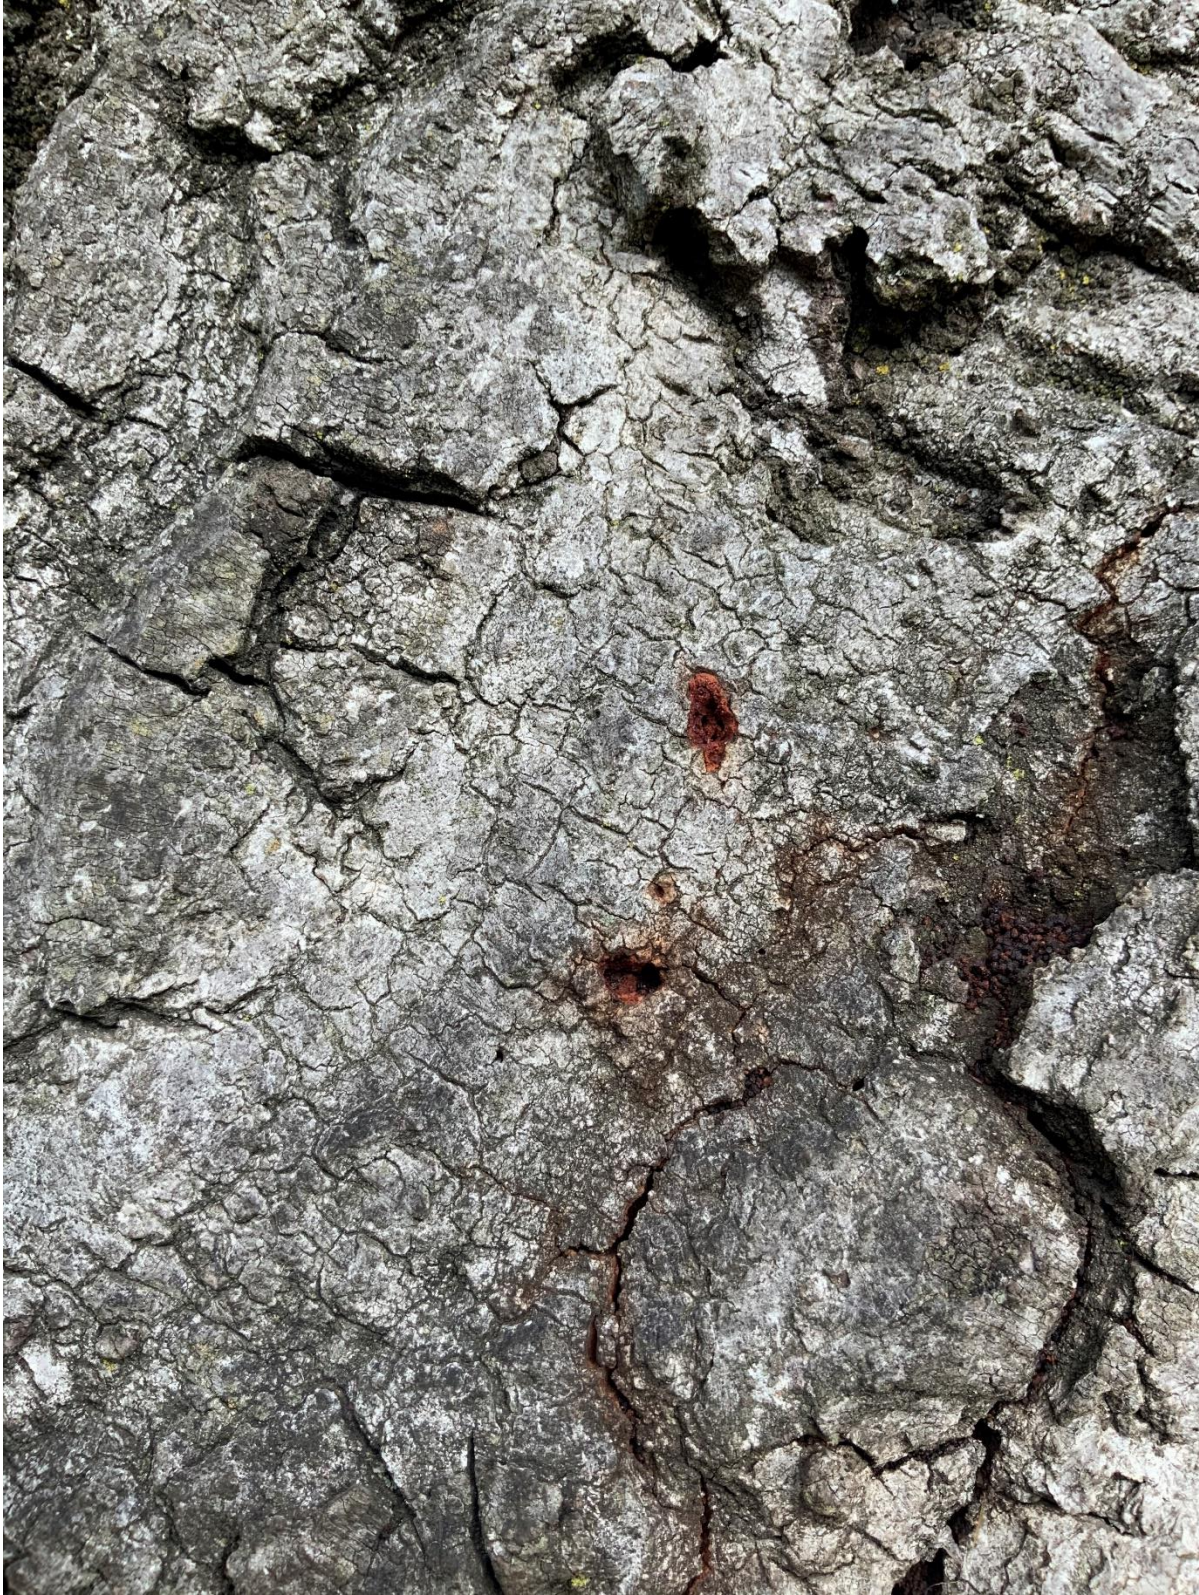
The tree's lower bole details an extensive history of insect activity by common secondary pests including bark beetles and native clearwing borers. When present on healthy trees native borers and bark beetles cause minimal damage to cambial tissues. However, when trees become overly stressed due to age or influence by external factors these opportunistic pests will utilize declining trees as mass breeding grounds. A mix of sawdust and excrement (frass) generated by these pests are pushed out through pin-sized exit/entry holes visible through the bark surface. Although the tree showed no signs of mass-attack by these pests at the time of my inspection, the detection of their presence combined with the overall condition of the tree further suggests the tree is in a state of significant decline.

Fresh frass from clearwing borers, foraging activity by woodpeckers, old bark beetle exit holes.

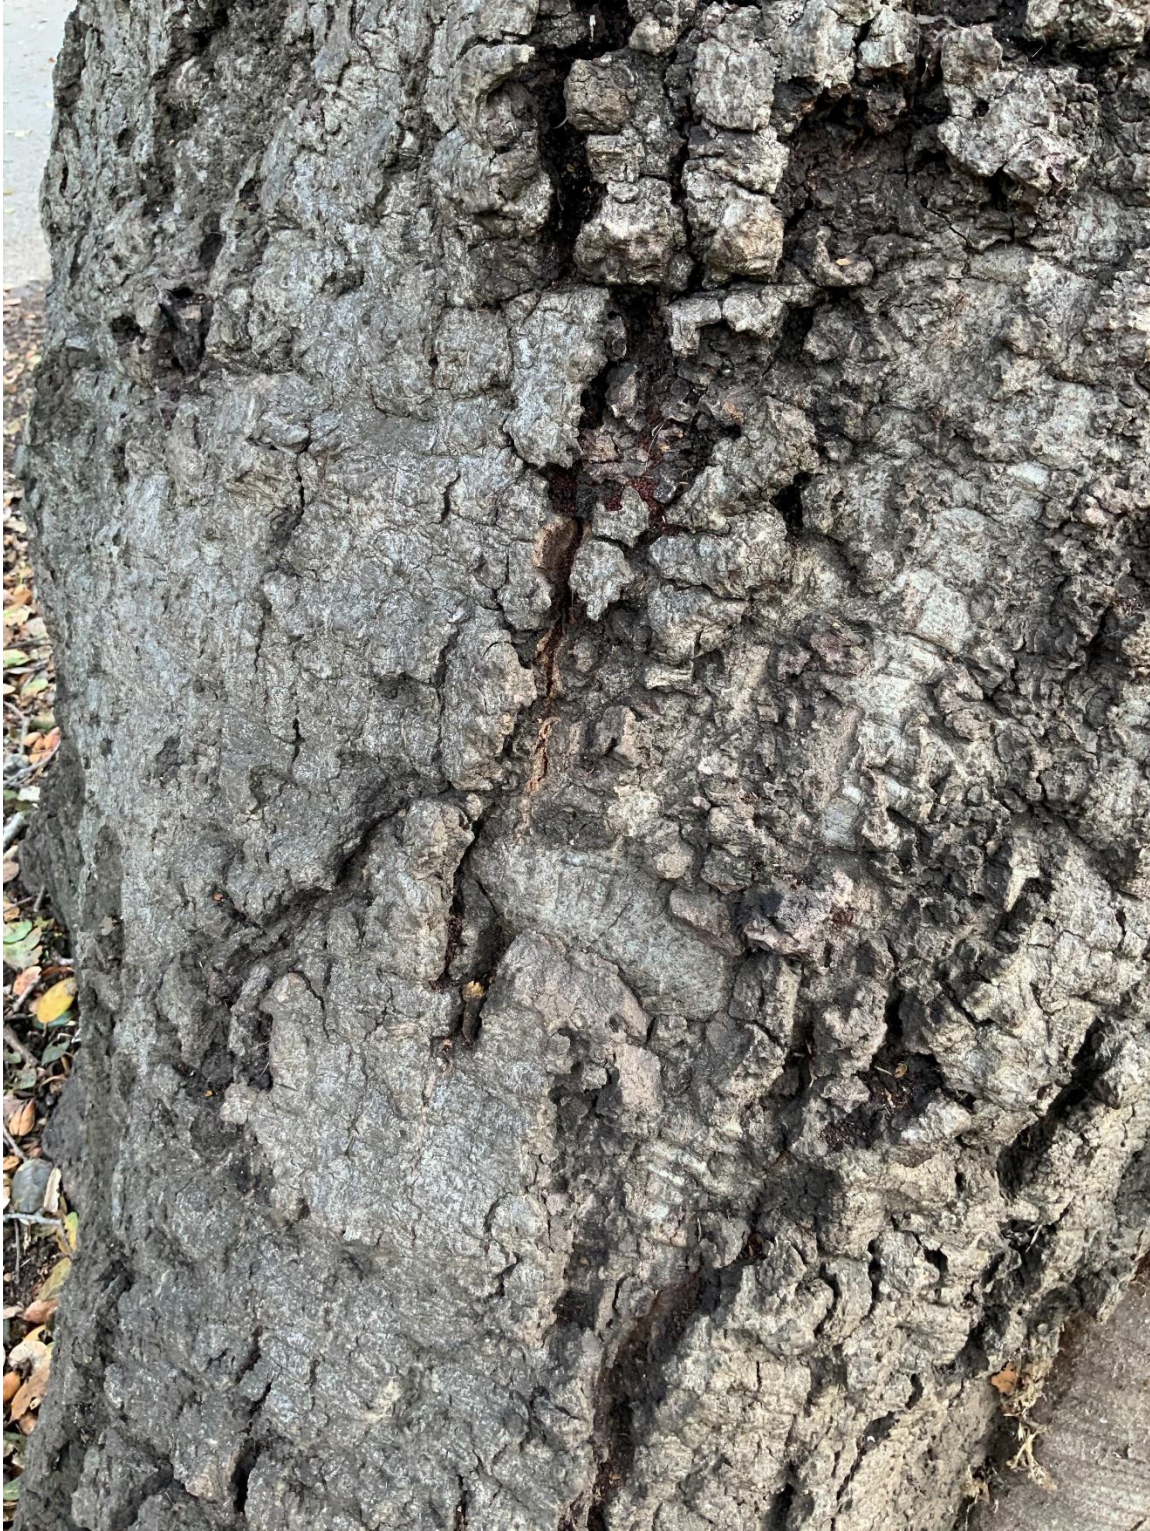
Extensive borer frass within cracks 5' above ground level on north side of tree.

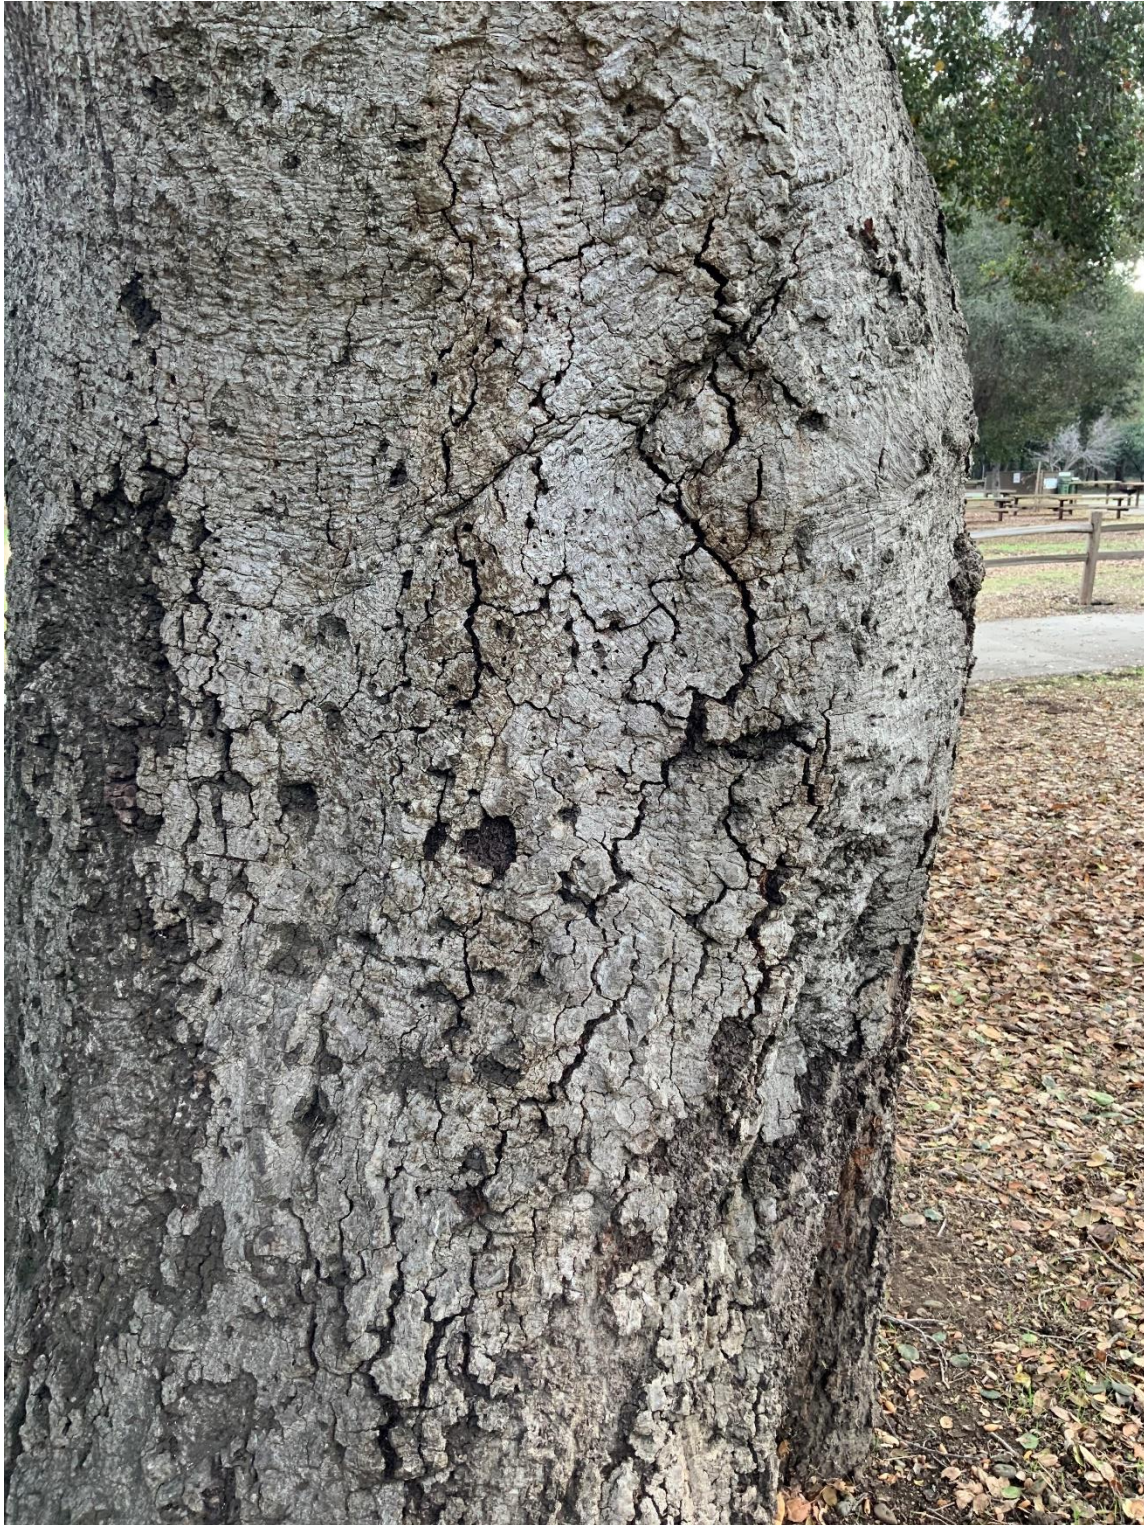
Extensive surface scarring of outer bark caused by chronic borer activity.

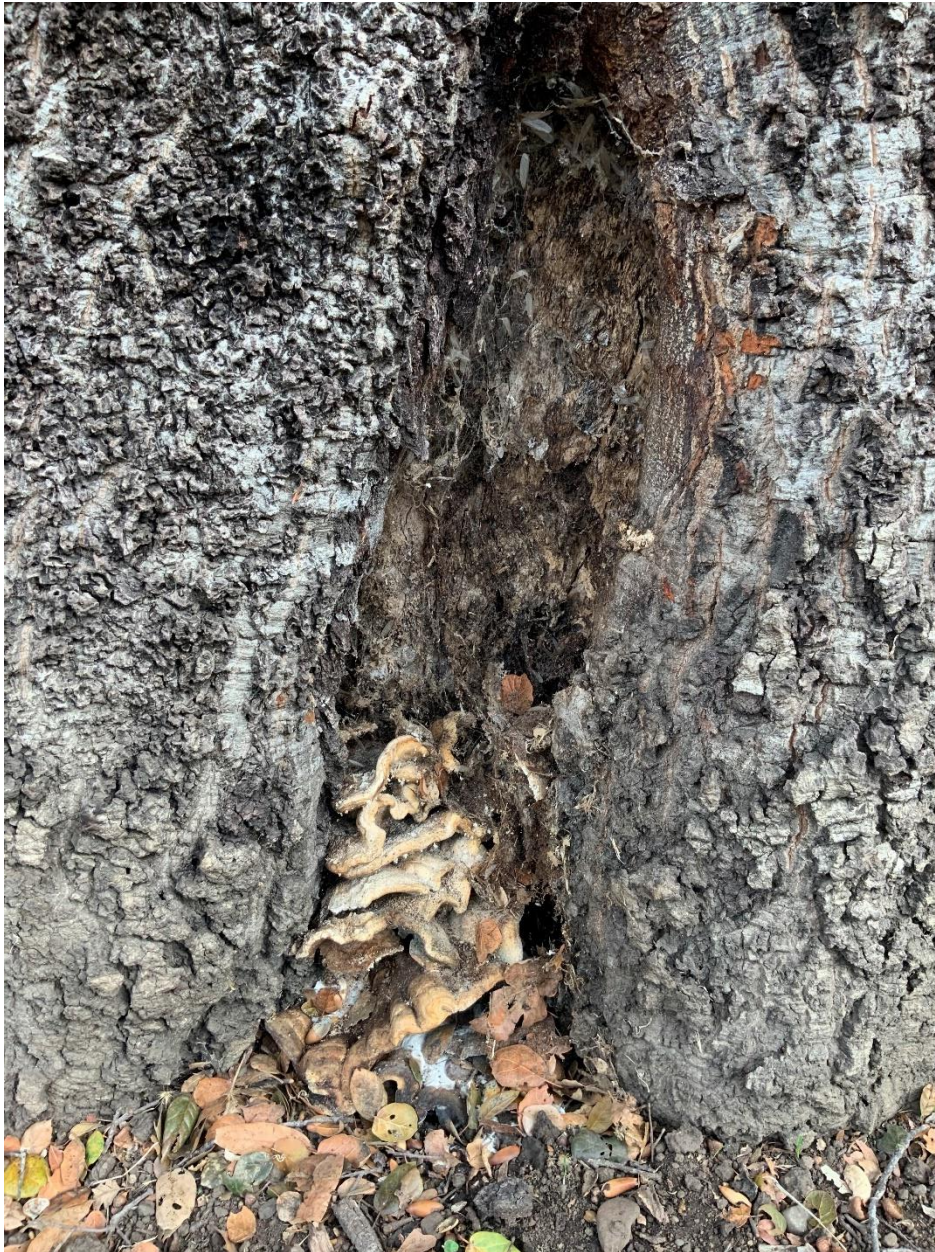
Thorough inspection of the fungal growth growing within the basal cavity displays characteristics consistent with a common wood decay fungi of oak *Laetiporus gilbertsonii* var. *pallidus*. This fungi is responsible for cubical brown rot of heartwood, which may lead to tree failure at the main stem or root flare. Presence of this fungi is considered a serious and irreparable condition due to the potential for extensive internal decay (Glaeser and Smith). Probing the exposed wood above the fruiting body was met with light resistance and confirming extensive internal decay. To better understand the severity of internal decay inspection with a IML Resistance Drill was conducted immediately after the initial visual risk assessment.

Dried fruiting bodies of *Laetiporus gilbertsonii* var. *pallidus*.

The only defect of concern evaluated as part of this risk assessment included a cavity at the root crown with fruiting bodies of a significant wood decay fungi, *Laetiporus gilbertsonii* var. *pallidus*. Although stress cracks on scaffold limbs and decay in the canopy are present, they were not evaluated as major risk factors due to observation of prior maintenance including pruning and installation of static load cables, both considered adequate protection factors.
